OARS Bacteria Monitoring Results—2022

Updated November 2, 2022

2022 Results (May 16, 2022–September 12, 2022)

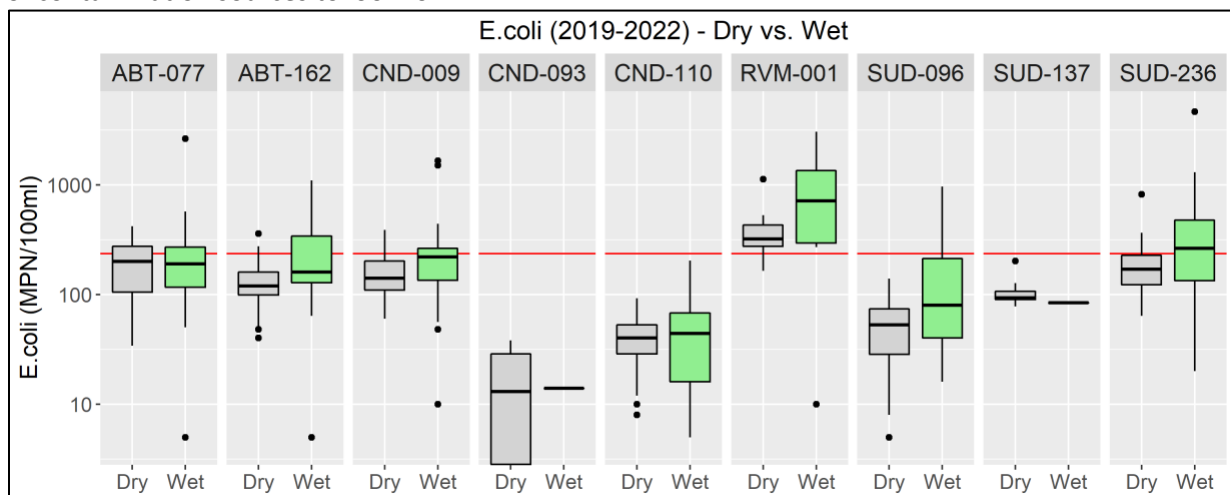
## Dry vs. Wet Weather

The following graph groups *E. coli* results based on the previous 48-hour precipitation. Wet weather is defined as 48-hour precipitation exceeding 0.10 inches, and dry weather is less than 0.10 inches. When dry weather *E. coli* is high, such as at sites ABT-077 and RVM-001, there is most likely a sanitary sewer source of bacteria that provides flow during all weather conditions. When *E. coli* is only high in wet weather, such as at site SUD-096, the bacteria source is most likely from surface runoff. Sites ABT-162, CND-009, and SUD-236 have definite wet-weather signals, but the dry-weather results are also high enough to raise concerns. In the case of CND-009, the wet-weather signal could be reflecting the high-flows coming from River Meadow Brook (RVM-001), which enters the Concord just upstream of CND-009 and has confirmed sewer contamination. This wet vs. dry analysis helps us know what types of contamination sources to look for.
