**Protecting Trout-Bearing Streams of the Sudbury River Watershed  
Final Report – September 2014  
S. Flint, OARS**

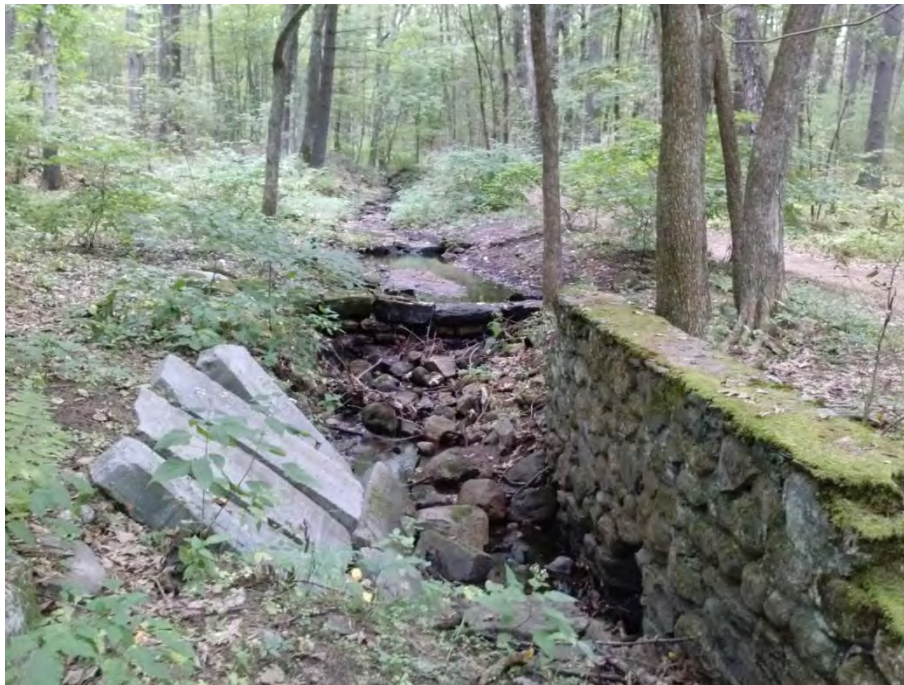
**Figure 2: Culvert on unnamed tributary to Cranberry Brook**

An unnamed tributary to Cranberry Brook runs from near small parking lot at the junction of Mosher Lane and Concord Road into the Marlborough-Sudbury State Forest (owned by DCR), the Desert Parcel (City of Marlborough). About half way down its course, the brook passes through a small culvert (Figure 2) under Old Concord Road, which is now a walking trail. The culvert is rated a "moderate barrier" to passage. About 18 feet upstream of the culvert is a small (20-inches tall) stone block dam; about 25 ft farther upstream is a second, smaller stone dam. The stream joins Cranberry Brook (a Cold Water Fishery Resource) downstream of White Pond Road and upstream Cranberry Brook's crossing with Old Concord Road Trail. OARS collected water temperature data in the stream (just upstream of the culvert at Old Concord Road Trail) over the summer of 2014 (data below) that suggest that the stream is an good cold water fishery stream. Figure 3 shows water temperature data from the unnamed tributary

- remediating the culvert on the unnamed tributary to Cranberry Brook at Old Concord Road trail
- Start discussions with the Hudson Conservation Commission about remediating the culvert on Cranberry Brook at White Pond Road.

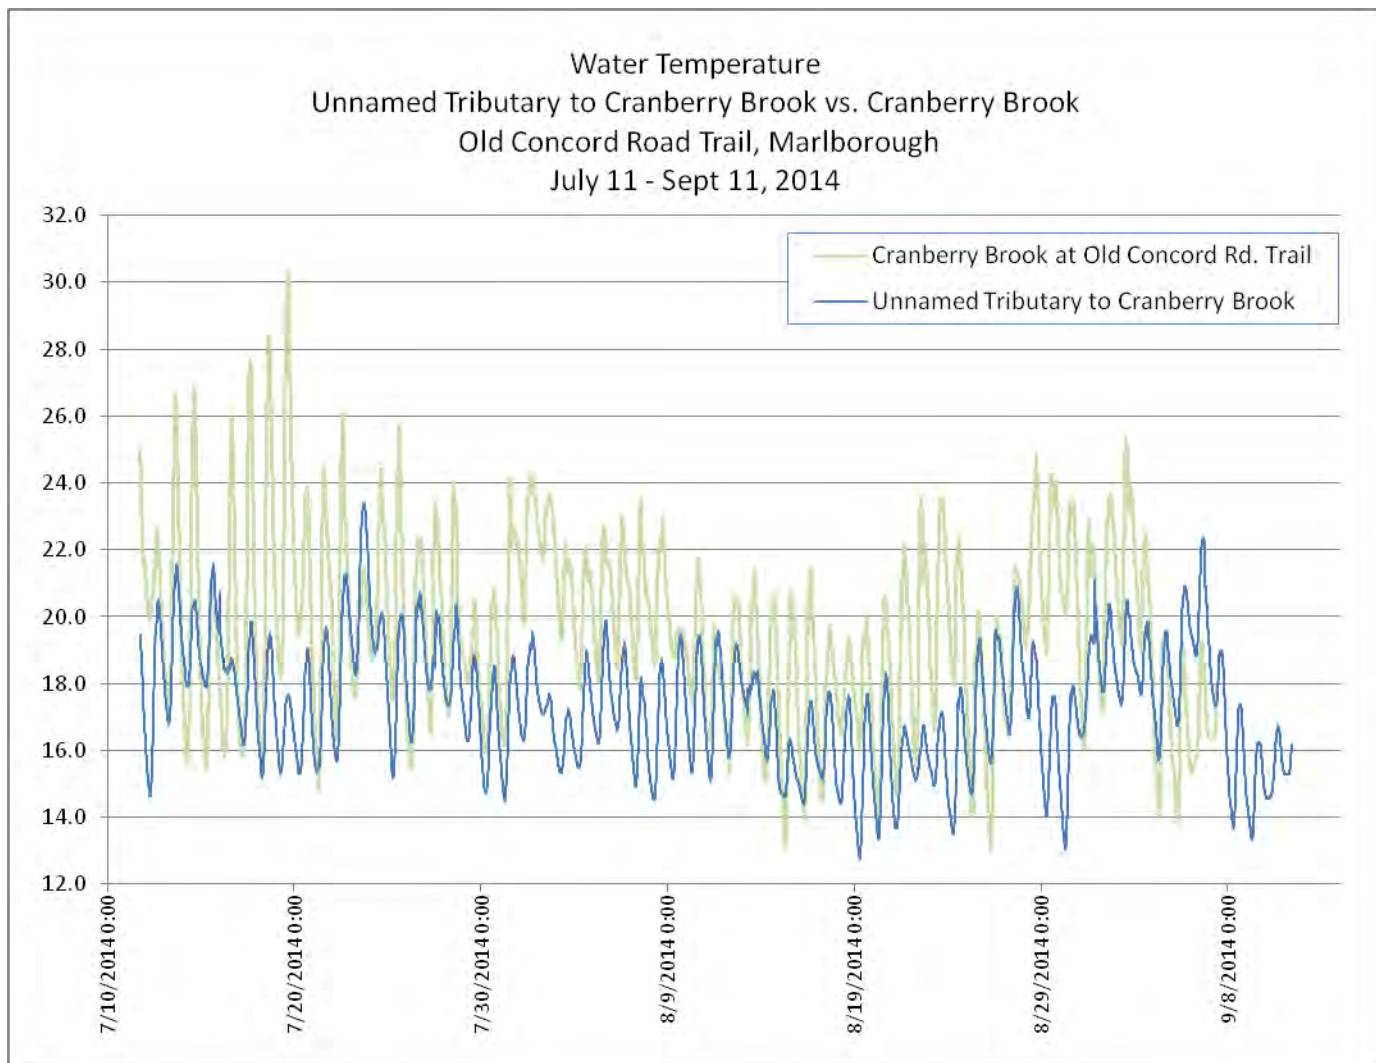
Figure 3: Water Temperature Data - Summer 2014

compared with data from Cranberry Brook taken just downstream of the confluence of the tributary and Cranberry Brook.

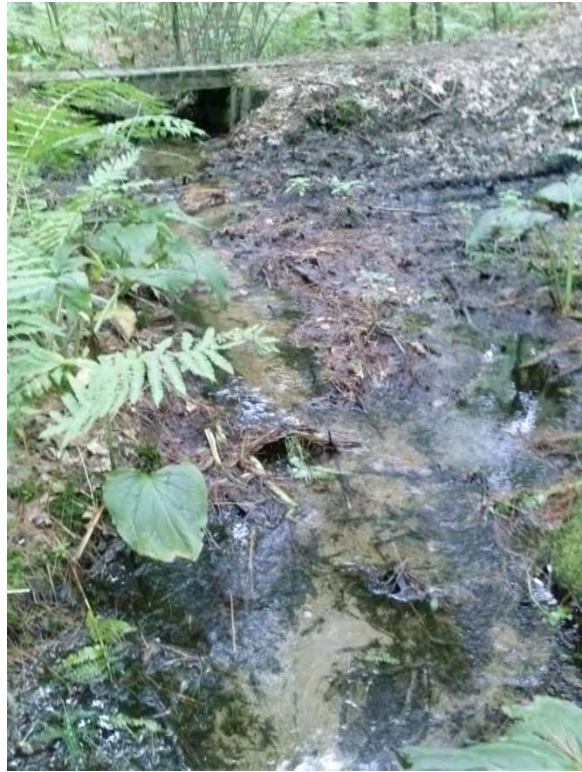
Figure 4: Erosion at unnamed tributary

- The trail in the “Hop Brook Marsh” conservation area crossing the unnamed tributary to Hop Brook shows signs of erosion from the hillsides and AVT tracks through the stream. Figure 4 looking upstream from below the footbridge.
- A large (4 ft high) pile of grass clippings was found on the upstream side of the culvert at Trout Brook at Graham Path, Marlborough.
- Yard waste and grass clippings were frequently seen at the edges of lawns abutting the streams.
- A patch of *Phragmites* is growing in the beaver impounded section of Cranberry Brook upstream of White Pond Road in Hudson.
- Water quality in the beaver impoundment upstream of White Pond Road is poor for fish (very low dissolved oxygen levels, 3.4%, and low pH 5.68).

- Discuss the trail erosion and AVT use on near the unnamed tributary to Hop Brook with Sudbury Conservation Commission.
- Request Mass Fish and Wildlife electrofishing surveys on:

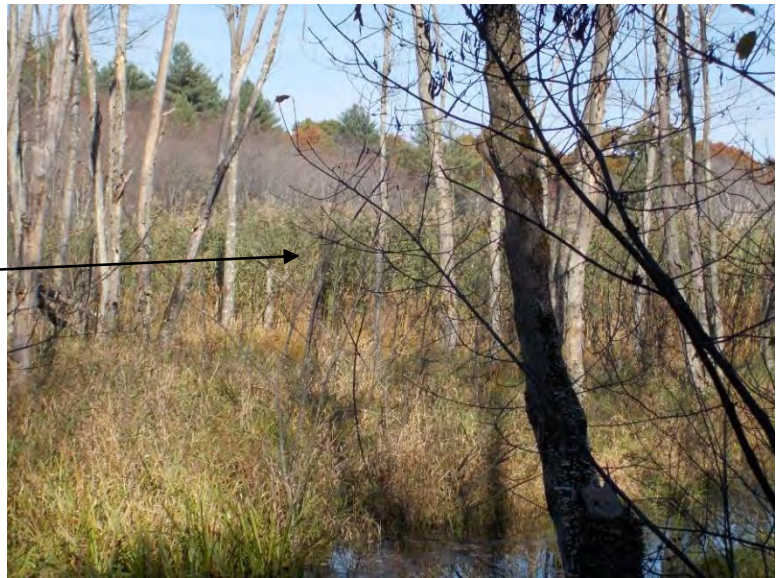
Figure 5: Beaver impoundment of Cranberry Brook

The upper section of Cranberry Brook is affected by a large, active beaver impoundment upstream of White Pond Road and is a section that appears to have been used as cranberry bogs. The culvert at White Pond Road, Hudson, has a large scour pool downstream. The section between Parmenter Road and Goodale Street was dry in October and was not surveyed. At the headwater of the stream, between Goodale Street and Vega Road, there is a 350-ft long culvert with a small pond at the inlet.

Phragmites in beaver impoundment. →

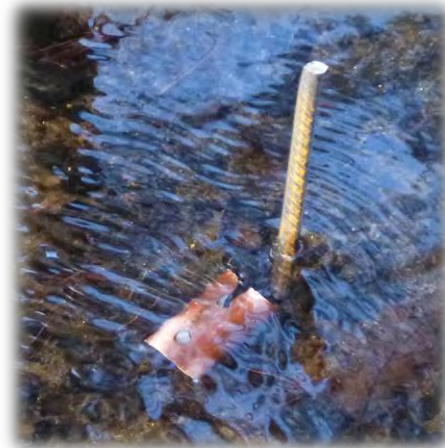
Figure 8: Water temp. logger installation

**Temperature monitoring:** Temperature monitoring was conducted to assess current temperature conditions and contribute to longer-term understanding of the effects of climate change on small trout-bearing streams. The OARS logging protocol was developed based on recommendations from USGS (pers.com. David Armstrong) and Washington State Department of Ecology (2003). Onset TidBit temperature loggers were checked for accuracy before deployment and are installed at nine locations: Hop Brook (2 locations), Cranberry Brook (4 locations), Trout Brook (2 locations), and the unnamed tributary to Hop Brook. To record paired air and water temperatures, four locations had air temperature loggers installed within about 10 feet of the stream temperature logger. Water temperature loggers were installed in mid-channel, about 3-6 inches above the streambed, and deep enough to remain underwater (hopefully) throughout the year. Air temperature loggers were hung about 4 feet off the ground, within about 10 feet of the water temperature logger, on the north side of a tree or in the shade of another structure.

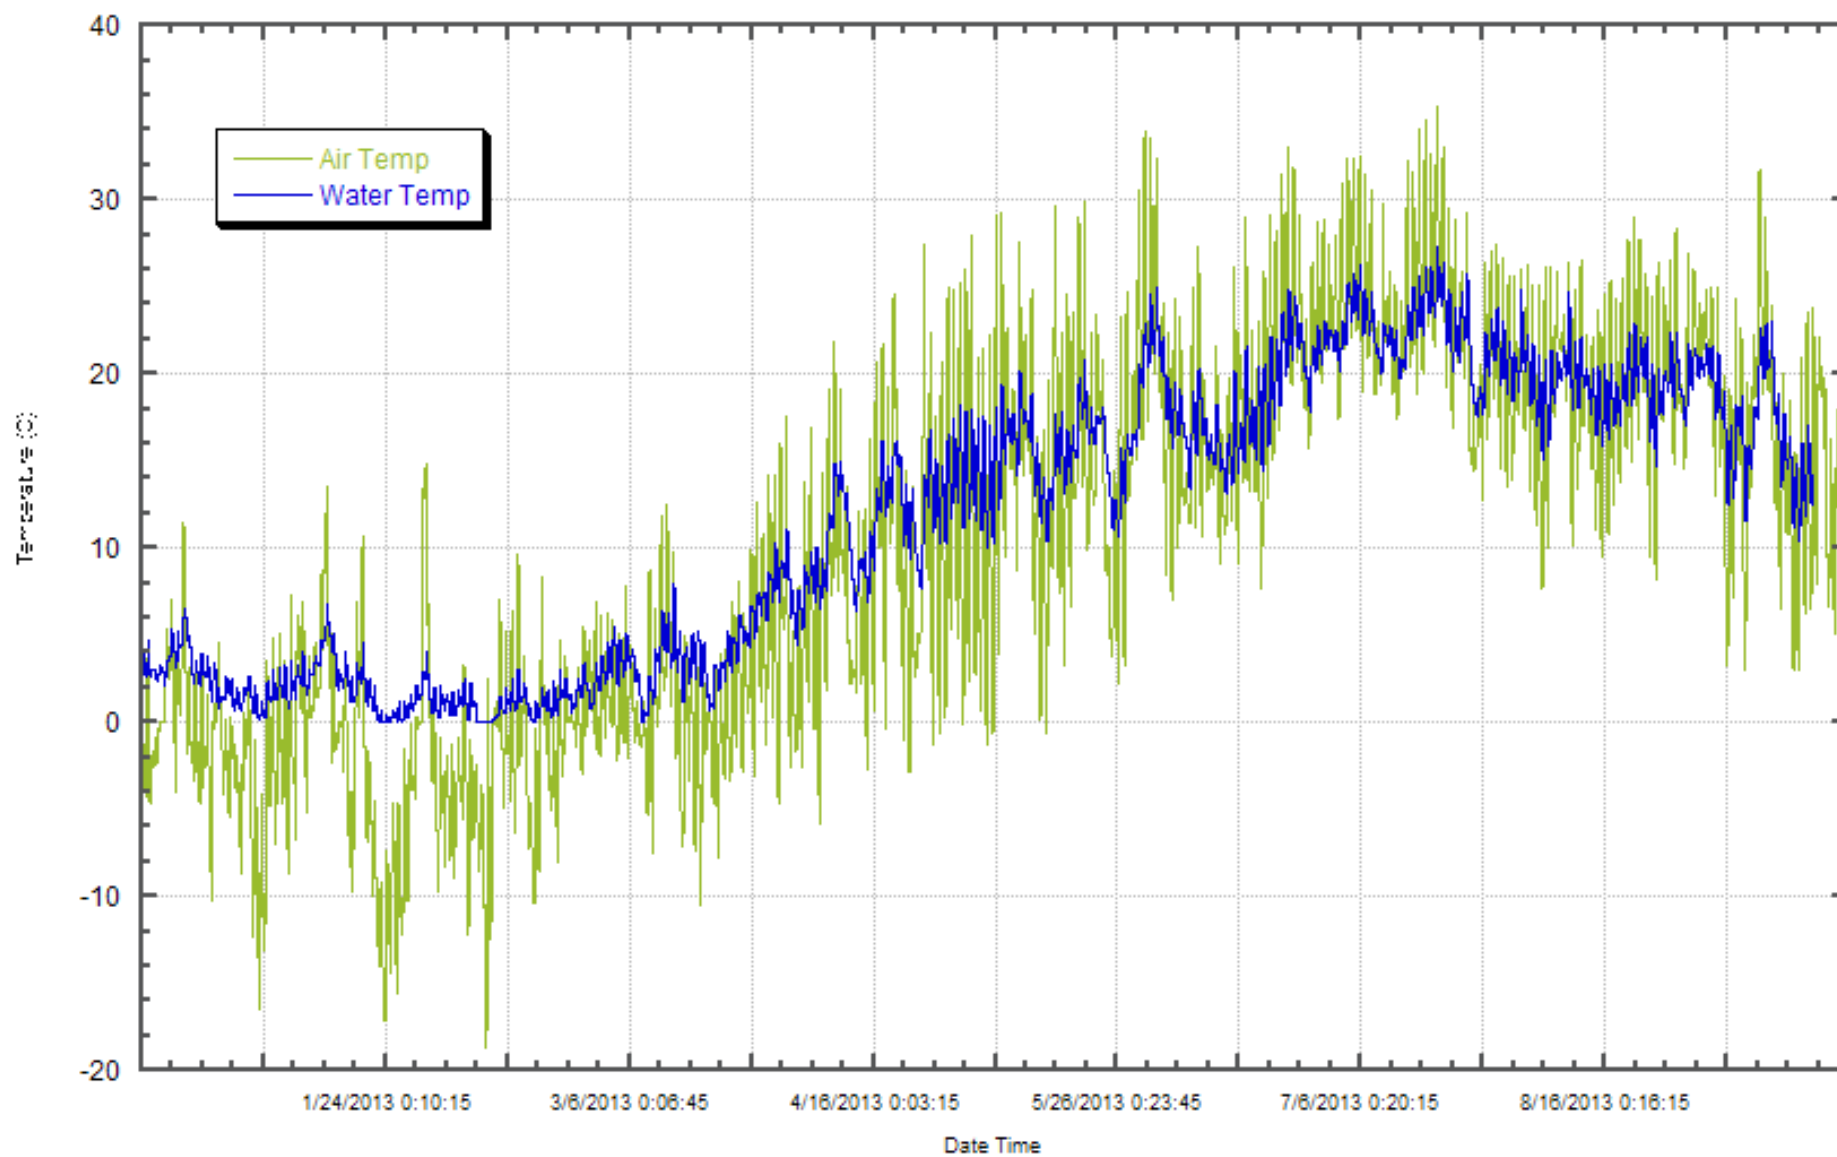
Figure 10: Air and water temperatures, Trout Brook, 2013

Figures 10 -13 show: (1) air and water temperature records for Trout Brook over 2013, (2) Trout Brook over the (arguably) hottest week of the summer of 2013, (3) and a three-site comparison of temperatures for Cranberry Brook, an unnamed tributary (labeled “seep”) to Hop Brook, and Hop Brook near Surrey Lane (downstream of the confluence of Cranberry Brook with Hop Brook) from July 15 to Sept 15, 2013 ( a summer period that is commonly used in analysis of stream temperature data), and (4) the unnamed tributary to Cranberry Brook compared with Cranberry Brook immediately downstream of the confluence of the tributary with Cranberry Brook.

It is worth noting that stream temperatures at the Trout Brook site went about 25°C on eight days over the summer, including five successive days in July 2013. This is the same period of time when a fish kill was observed on the nearby Assabet River in the open sections of the river in Stow, MA. Over the summer (after the logger was re-installed on 7/24/13), the maximum temperature recorded at the unnamed tributary to Hop Brook was 19.4°C.

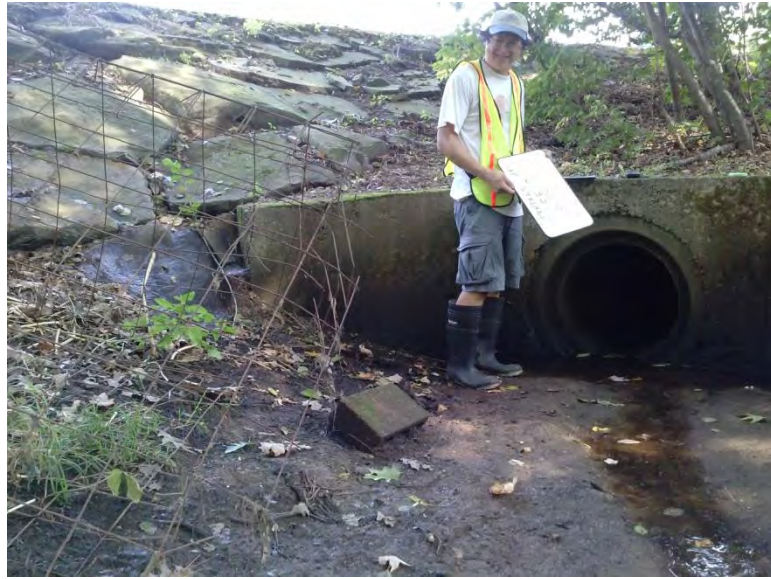
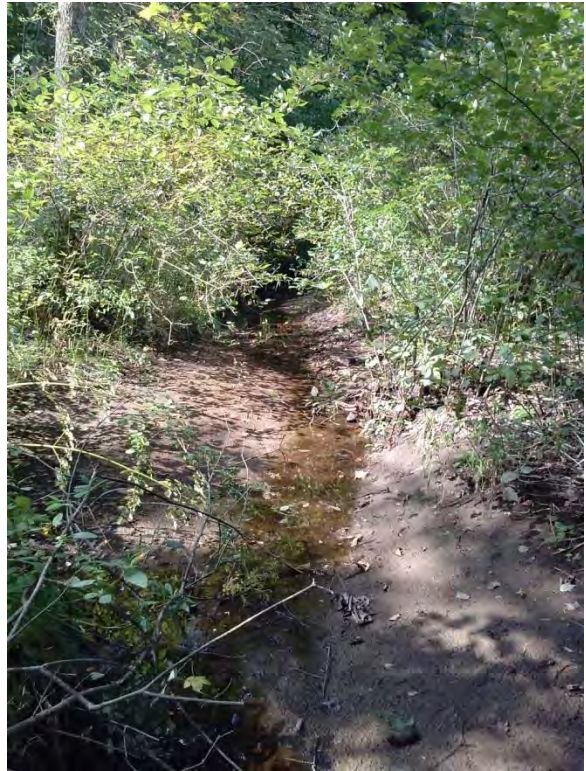
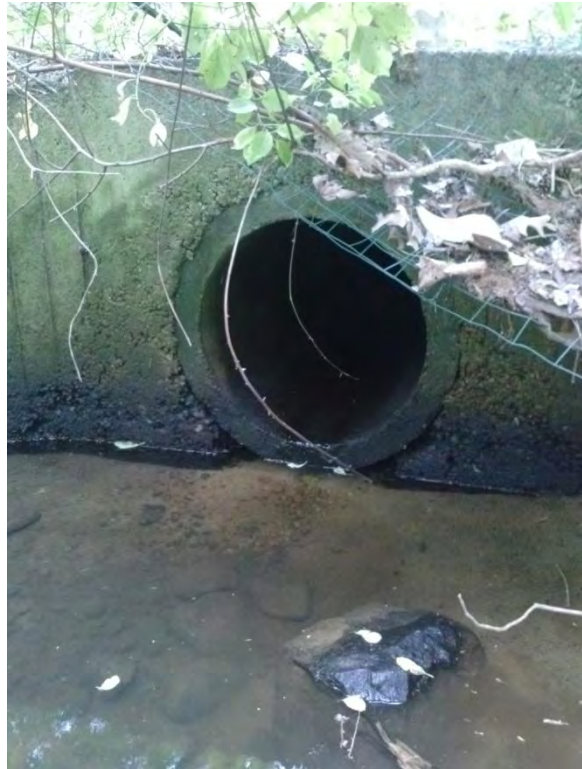
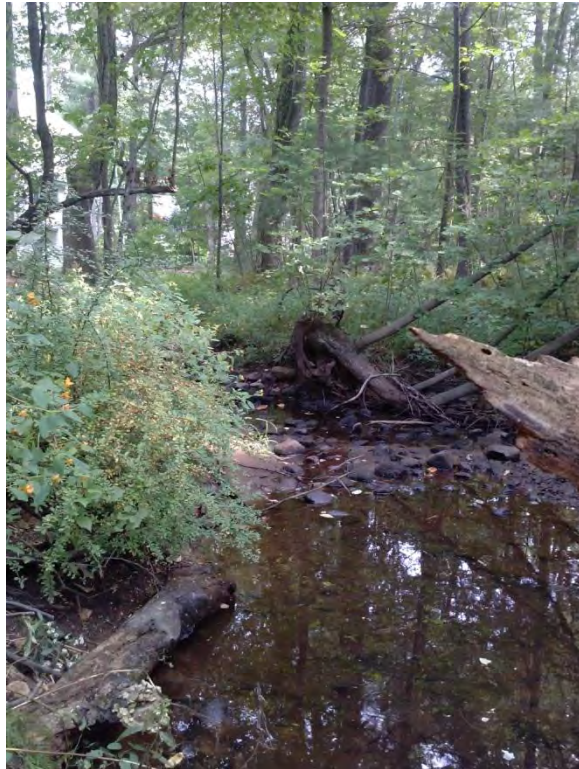
Culvert at Harper Lane and Woodcock Lane, Marlborough Inlet

- a 300-ft long culvert at the corner of Harper and Woodcock Lane (fish, likely trout, were observed in the scour hole at the outlet of this culvert)
- a buried section of stream (1200+ feet) under Minehan Lane; the inlet is a vertical concrete box overflow from a small pond
- a 400-ft long culvert under Prendiville Way on a tributary branch of Trout Brook

- Start discussions with Marlborough Conservation Commission of possibly remediating culverts:
  - shortening/daylighting the culvert at Woodcock Lane
  - removing or remediating the old dam at Hemenway Road

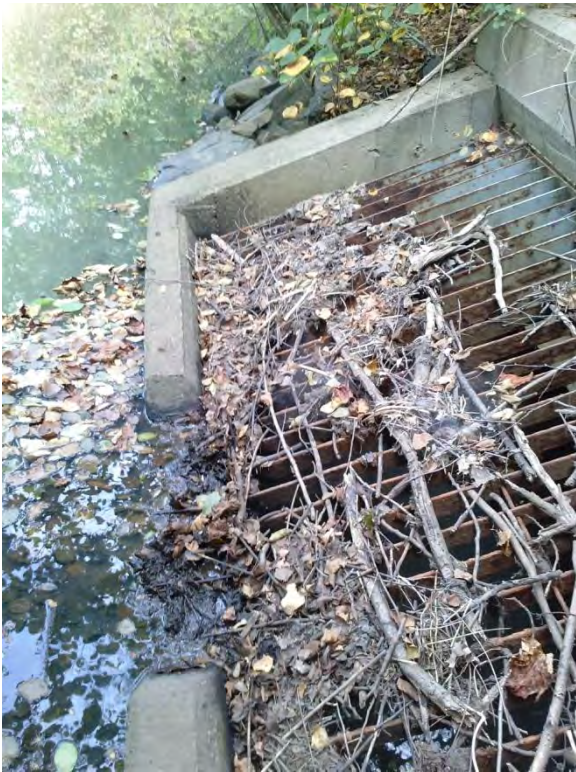
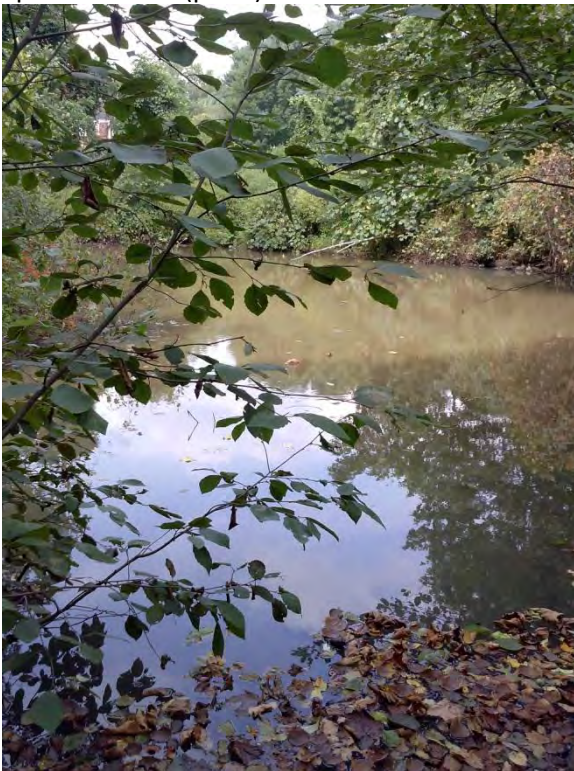
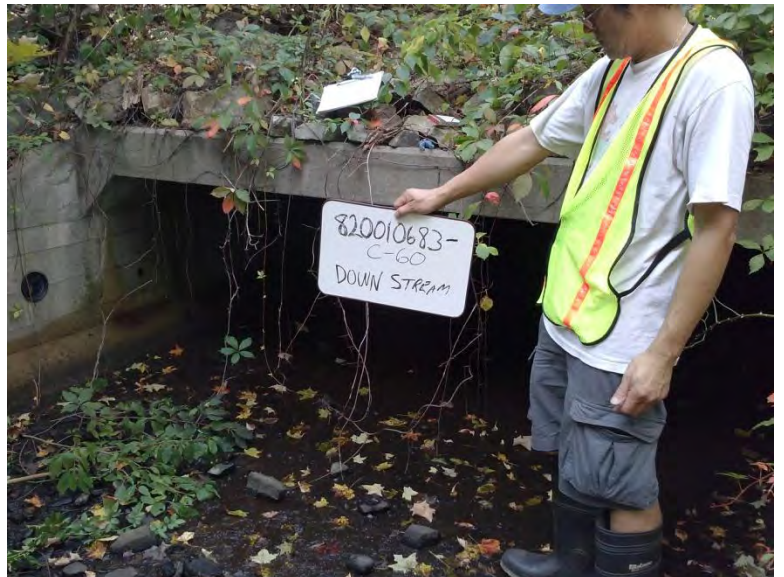
Old dam and pond at Hemenway Street, Marlborough  
Dam spillway/ culvert inlet

- an old dam forms a 36" drop at the inlet of the culvert under Hemenway Street
