## SUDBURY RIVER ASHLAND BACTERIA STUDY—2024

Published February 14, 2025

The following is a summary of OARS' monitoring and source-tracking results for *E. coli* bacteria in the Sudbury River Ashland special study. This study was funded by a grant from the Greater Lowell Community Foundation. We also thank our team of dedicated volunteers for helping collect the river water samples.

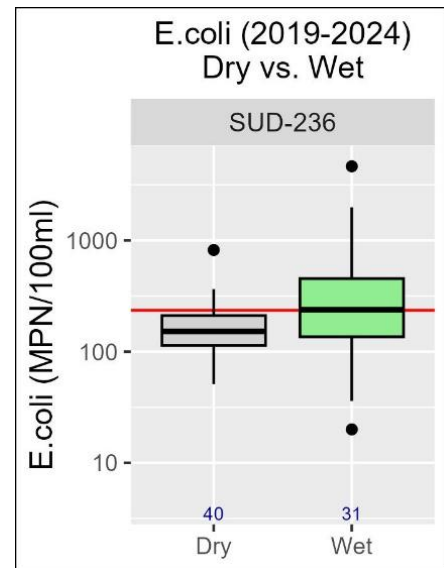
Figure 1: Ashland SUD-236 bacteria dry vs. wet all years. Red line represents the BAV threshold of 235 MPN/100ml.

OARS' bacteria monitoring program (launched in 2019) highlighted frequent elevated *E. coli* bacteria levels at the Sudbury River sampling site along Chestnut Street in Ashland between the Union Street bridge and Cold Stream Brook (site # SUD-236). During the six years between 2019 and 2024, 35% of bacteria samples at this site (out of 71 total samples) exceeded the EPA's Beach Action Value (BAV) swimming threshold of 235 CFU-MPN per 100 ml<sup>1</sup>. Three samples (6/29/20, 8/3/20, and 7/17/23) even exceeded the MassDEP boating threshold of 1260 CFU-MPN per 100 ml. An analysis of the separate wet and dry-weather<sup>2</sup> sample data (Figure 1) shows that median wet-weather results are statistically greater than median dry-weather results, but it also shows that 24% of dry-weather samples exceeded the BAV. High wet-weather bacteria levels can imply contamination from surface and stormwater runoff and could be from

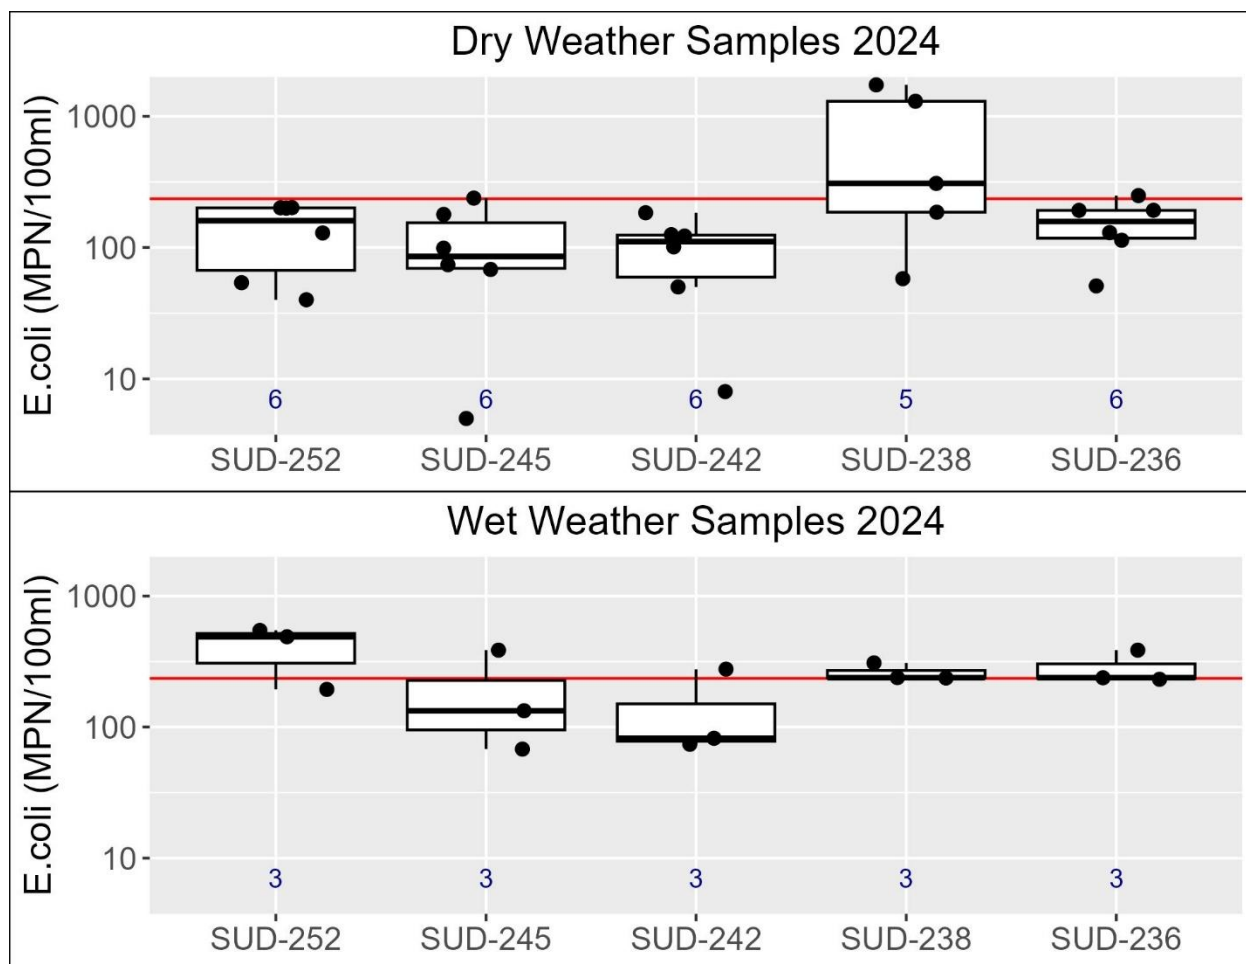
Figure 3: Boxplot analysis of *E. coli* results for dry and wet-weather sampling dates. The dots represent actual samples. Wet weather is defined as >0.1 inches of rain in the previous 48 hours. The sites are listed left to right from upstream to downstream. Dry and wet-weather pollution is evident upstream of the SUD-238 site. The red line represents the BAV threshold of 235 MPN/100ml.

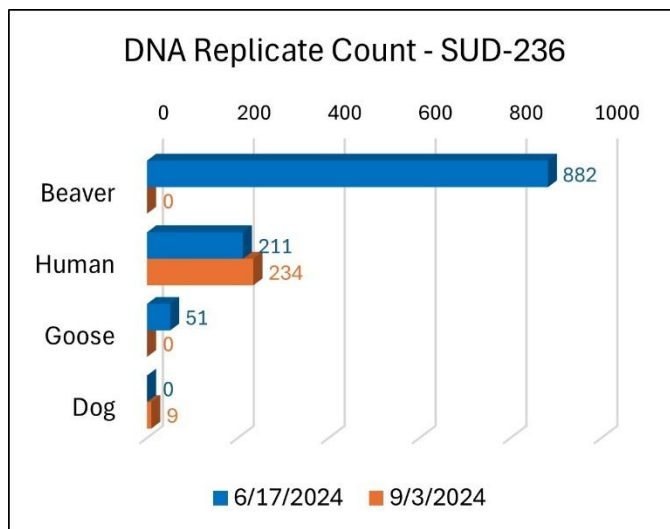
*Figure 4: DNA results, analyzed by Jonah Ventures. Results are averages based on three replicates. The 6/17 sample was a wet-weather sample with moderately high flows. The 9/3 sample was dry-weather with very low flows.*

The results of the two samples were quite different (Figure 4). The first sample was collected during wet weather in moderately high flows. This sample showed a large proportion of beaver DNA and also some goose DNA, supporting the hypothesis that upstream wet-weather bacteria counts are probably from wildlife. Both samples had a significant portion of human DNA, and the second sample, which was collected during a long period of dry weather, was almost 100% human DNA. It had no beaver or goose

DNA at all. These results confirmed that humans were a significant source of DNA in the samples<sup>4</sup>. The dry-weather results support the suspicion of potential sewage pollution upstream of the dry-weather bacteria hot-spot, SUD-238. Dog DNA was not present in any significant amount in either sample.

<sup>4</sup> The copy counts of 211 and 234 for human DNA are significant in comparison to OARS' 2022 DNA test results of 271 copies from River Meadow Brook in Lowell, where OARS has demonstrated significant bacterial pollution and a dominance of human sources in a dense urban environment. See "OARS River Meadow Brook Bacteria Monitoring Results – 2022", Feb. 7, 2022.

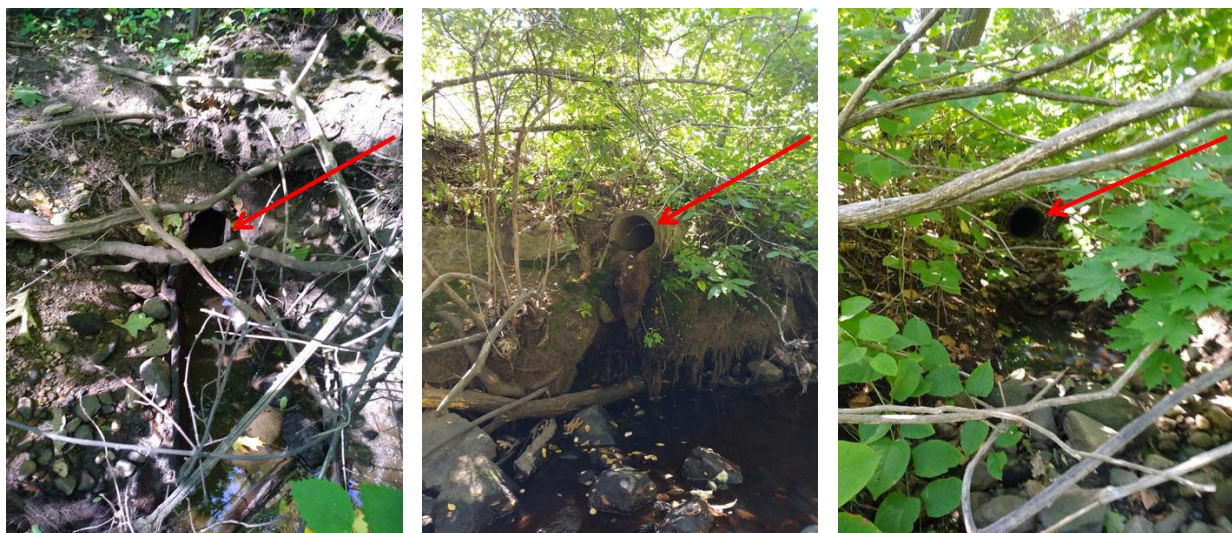
*Figure 6: Pipes with elevated detergent levels. Left to right: AS-03, AS-08, AS-09. AS-03 had very high levels – located river right facing downstream near the middle of the parking lot for 50 Main Street.*

This detergent survey clearly identified two pipes that need to be addressed. The AS-03 pipe behind the parking lot should be easy to map and resolve. This is most likely a short pipe from the 50 Main Street facility. The other pipe, the outfall pipe feeding the side stream and AS-04/AS-06, is connected to a large network of street sewers for the whole downtown area of Ashland. This will require more work on the part of the Public Works Department, but there are clearly some very strong pollution sources connected to this street sewer. The combination of high detergent levels in the stream and a bacteria hot-spot downstream of the stream's confluence and dry-weather human DNA downstream of the confluence is strong evidence of a sanitary sewer connection feeding this stormwater outfall.

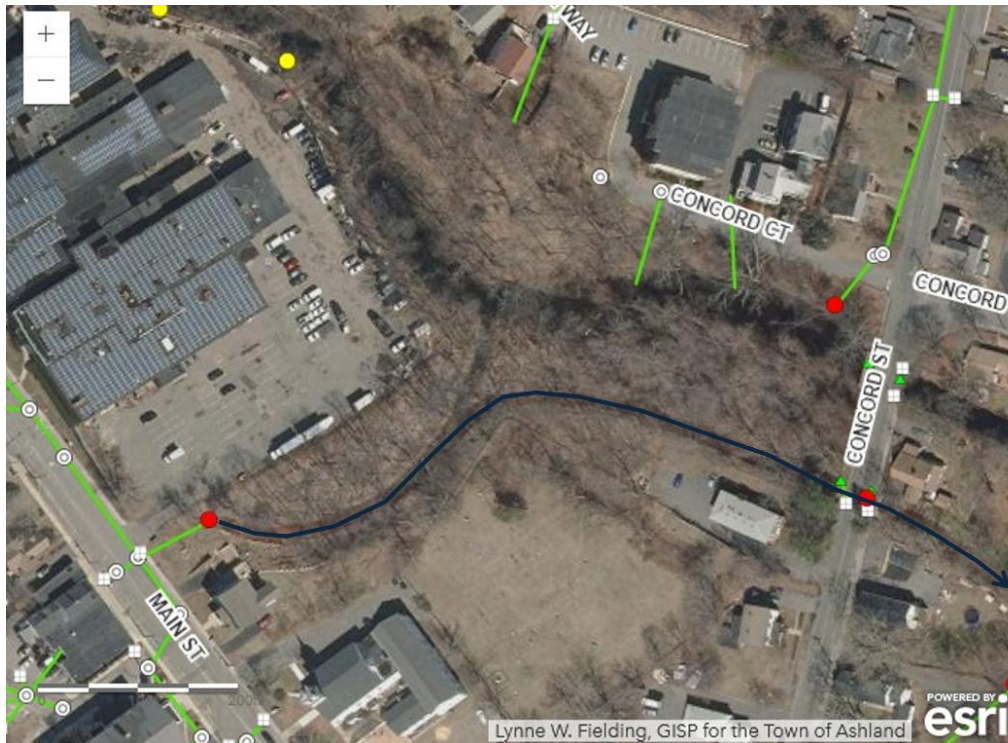
Figure 7: Ashland stormwater system map showing on the left side of the image the municipal outfall (red dot) from Main St. feeding the side stream (blue line) that was measured with high detergent levels. The Sudbury River is just north of the side stream.

down the river on 9/11/24 and tested for detergents in each pipe that had flowing water, using a Chemets K-9400 test kit. There were many pipes along the river that did not have any flow at the time of the survey, which probably makes it safe to exclude them as dry-weather sanitary sewer sources. We did find several pipes and a side stream with noteworthy results (Figure 5). Pipes AS-03, AS-08, and AS-09 all had elevated results (see Figure 6 for pictures of the pipes). In particular, pipe AS-03 had extremely high detergent levels at 1.9 ppm. This pipe was located on river right (facing downstream) next to the parking lot for 50 Main Street. The side stream that we found also had very high detergent levels at or above 1 ppm. Sites AS-04 and AS-06 were both along this side stream, which runs parallel to the Sudbury River and joins the Sudbury 1100 feet upstream of site SUD-238. This stream originates between 50 Main Street and 98 Main Street at a municipal stormwater outfall (Figure 7).
